**SAS Superstructure**

Location: 04-SF-80-13.2 / 13.9

**Daily Diary Report by Bid Item**

Diary #: 529 Const Calendar Day: 310 Date: 10-Apr-2013 Wednesday

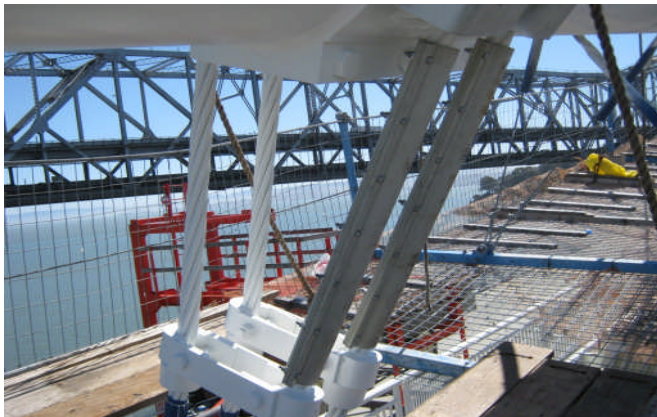
- From 12:00 until 12:30, lunch.
- From 12:30 until 15:00, Roger's crew was installing the suspender protection brackets at PP 98S. See below for a list of the work performed.

- The brackets were installed on the inboard suspender ropes at PP 98S located 50mm above the suspender clamp.
  - The 12mm, Grade A307 bolts were installed between the halves of the protection bracket, & the 2 halves of the bracket were worked together gradually by equalizing the gaps between the flanges of each half of the bracket while tightening the bolts. Once the plies were brought into contact (snug), the bolts

were tightened an additional one third of a turn. Jam nuts were installed & tightened behind the nuts.  
 - See attached photo.

CCO-200 suspender protection brackets installed at PP 98S

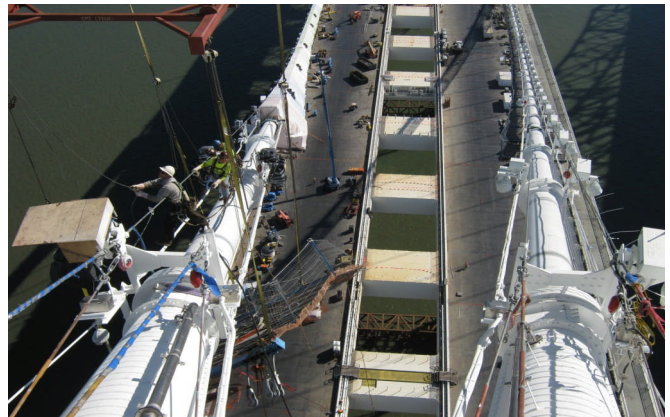
- At 07:00, I arrived at the pier-7 office, & arrived on the bridge at 07:30.
- From 07:30 until 09:30, Tony's crew was removing the upper portions of the North main-span catwalk. They removed the catwalk between PPs 44N & 50N. See attached photo.

Removing a portion of the North main-span catwalk
